**DEPARTMENT OF TRANSPORTATION**

Contract #: 04-0120F4Cty: SF/ALA Rte: 80 PM: 13.2/13.9File #: 82.28**WELDING INSPECTION REPORT****Resident Engineer:**Siegenthaler, Peter**Address:** 333 Burma Road**City:** Oakland, CA 94607**Report No:** WIR-021624**Date Inspected:** 21-Feb-2011**Project Name:** SAS Superstructure**OSM Arrival Time:** 700**Prime Contractor:** American Bridge/Fluor Enterprises, a JV**OSM Departure Time:** 1530**Contractor:** Westmont Industries**Location:** Santa Fe Springs, CA.**CWI Name:** Ruben Dominguez**CWI Present:** Yes No**Inspected CWI report:** Yes No N/A**Rod Oven in Use:** Yes No N/A**Electrode to specification:** Yes No N/A**Weld Procedures Followed:** Yes No N/A**Qualified Welders:** Yes No N/A**Verified Joint Fit-up:** Yes No N/A**Approved Drawings:** Yes No N/A**Approved WPS:** Yes No N/A**Delayed / Cancelled:** Yes No N/A**Bridge No:** 34-0006**Component:** Travelers**Summary of Items Observed:**

**E2/E3-EB Traveler**

**SAS-WB Traveler**

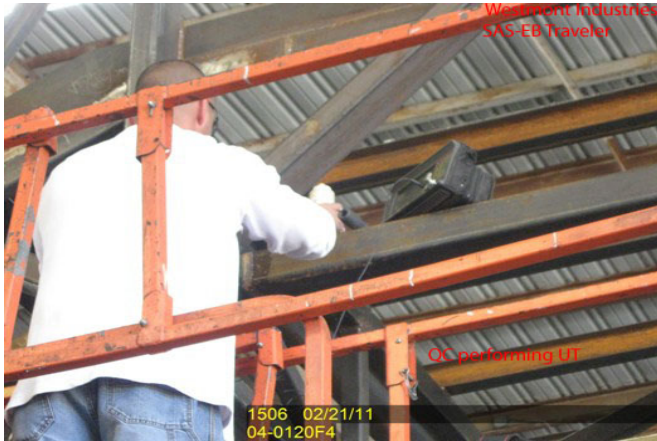
throughout the shift. Additionally, this QA Inspector observed WMI personnel Mr. Cesar Canales performing dimensional layout and fitting activities, on the above mentioned assembly. Additionally, this QA Inspector observed WMI production welder Mr. Daniel Grayum (WID # 3049) continuing to perform Flux Core Arc Welding (FCAW) activities on the SAS-WB Traveler. This QA Inspector observed Mr. Grayum performing the FCAW in all positions on tube steel material, randomly throughout the shift.

See attached picture below.
